Slope stability analysis for landslide mitigation in Satui, Tanah Bumbu, South Kalimantan

A Salimah

Abstract. Satui is a Tanah Bumbu sub-district that is in the territory of South Kalimantan yielding mainly coal. The illegal and uncontrolled coal mining formed a steep slope in this area. The slope was exactly shaped close to a telecommunication tower building and other buildings. The excavation in this area provoked an eroded and imbalanced slope thus triggering a landslide. This research is aimed to deal with erosion prevention and disaster risk reduction to mitigate the environmental impact. The investigations of slope and soil conditions are used to obtain soil data as the first stage of research. The second stage is analyzing the slope stability toward soil data. A stable slope condition is indicated by existing analysis with FoS 1.66. Yet to avoid future disaster risk, slope reinforcement by employing Geo-Anchor is performed. The last stage is executed by implementing the proposed drainage and slope surface formation.

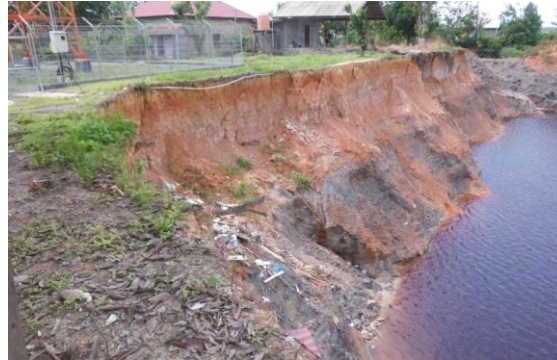
Figure 2. Slope condition after eroded

As can be seen, Figure 2 shows the steepness of the slope is adequately high and the edge of the original land getting eroded approaching the tower building as the effect of illegal coal mine excavation. Accordingly, prompt and precise mitigation is needed to prevent the continuity of erosion. Landslide mitigation includes; investigation survey, analysis, and reinforcement of the slope. The results from the survey and analysis will be considered in risk mitigation planning [15]. The countermeasure involves the construction of Geo-Anchor as slope surface reinforcement. Further improvements are to recondition the previous drainage. The new drainage is built to anticipate the absorption of rainwater into the pores of the soil which has the potential for raising the groundwater table and risk of slope failure.

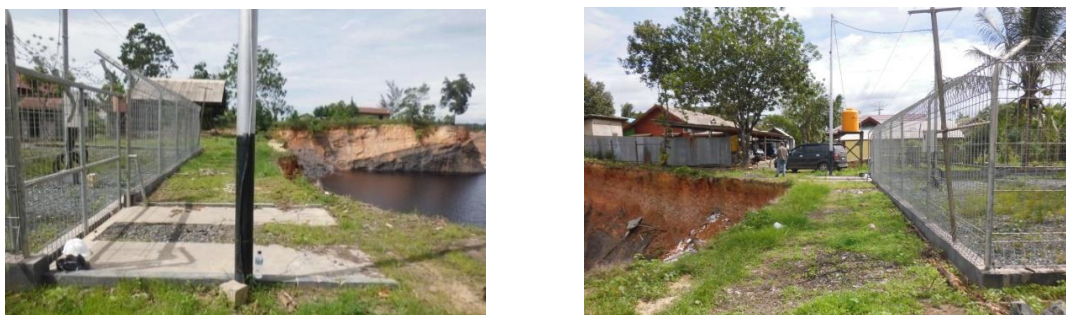
The road around the building area is still accessible enough, yet reaching the tower building area needs more caution since part of the pathway has been eroded due to slope failure even though it is still accessible as shown in Figure 4.

Figure 4. Pathway and edge of the fence after eroded

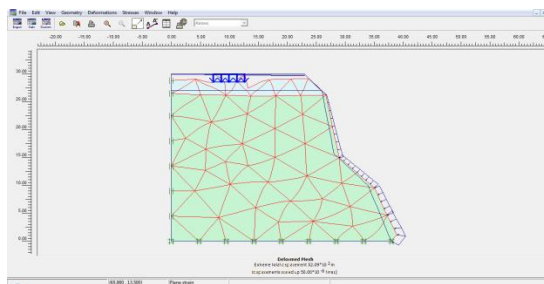
Figure 5. (a) Displacement for an existing condition,
(b) Condition of failure

Figure 5a shows the existing displacement condition. The area potential of the slipping zone is depicted in Figure 5b which total regional displacement are described as well. The result using Plaxis2D could describe the slip surface from crest and hill slope to foot slope at the existing condition. FoS in this case is 1.66 as seen in Figure 6 which describes that slope condition is quite stable because the FoS calculated is more than required ($FoS > 1.5$). The critical point on the failure plane is yet within the safety margin.

The next stage is analysis completed under the condition of erosion. The slope gains outer load from the weight of the tower and foundation of the building as equal load. As can be seen in figure 5, no significant movement occurs in the area building of the tower. The parameters of existing material design in Table 1 generates the numerical analysis as represented in Figure 6.
